### Pushing TBM design limits under Lake Mead

The race to complete the Lake Mead deep intake No. 3 tunnel in Nevada, USA, is, put simply, the story of a TBM being pushed beyond its design limitations to get the job done before the desert city of Las Vegas, quite literally, runs dry. Peter Kenyon of *TunnelTalk* speaks to Vegas Tunnel Constructors Project Manager Jim Nickerson for the contractor, and South Nevada Water Authority Project Manager Erika Moonin for the client, about an extreme drive through worse than anticipated ground under hydrostatic pressures that have so far reached 15 bar.

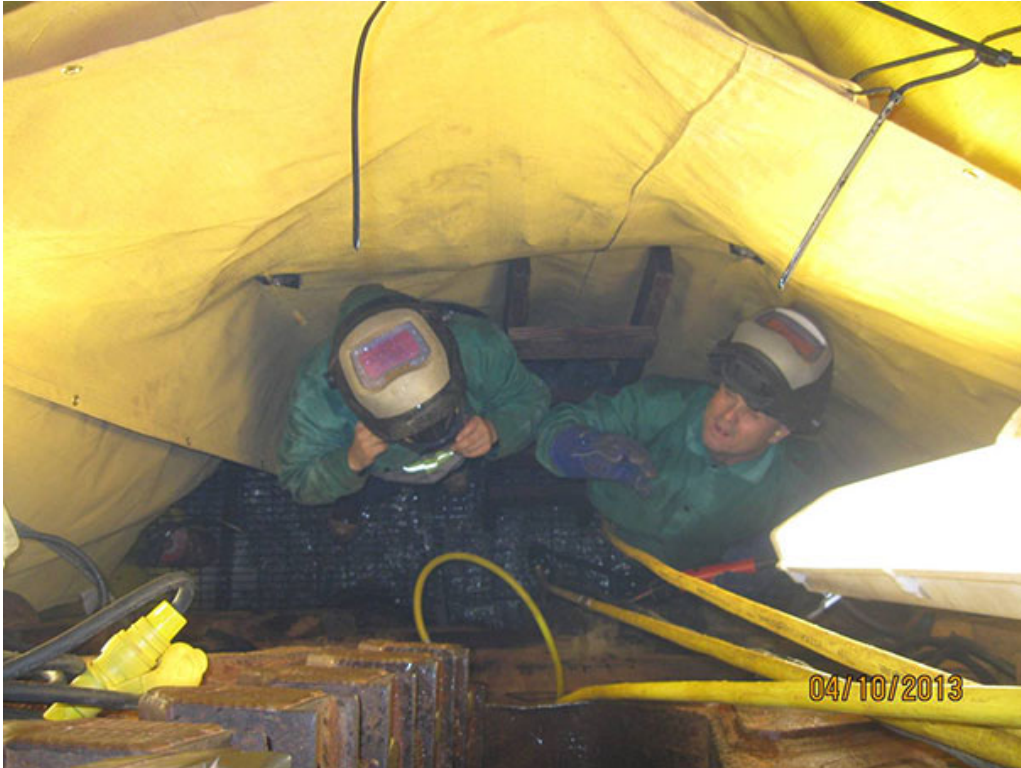
*View from above as crews repair the damaged cutterhead in a hand-excavated niche ahead of the face.*

Work began immediately on changing the cutters from outside the cutterhead, but once crews were able to inspect the centre section they found the disks could not be removed. “After further investigation we found that the whole centre of the cutterhead was worn all the way into the structure. The disk cutters were more than half gone, and the wear plates had worn through and there was approximately 8in of metal loss into the structure of the cutterhead and the disk cutter housings. So now we were confronted with a very large structural repair of the cutterhead while at the same time also being faced with all this water,” recalled Nickerson.

“The only way to complete the repair was to go out in front and excavate a niche into the face, and work on this started on April 1, 2013. Once the niche was excavated we then diverted the water inflows down to the invert to create a perfectly dry area to facilitate a

structural repair, using induction heating to assist in the process. Herrenknecht technicians were here advising with the work being done on site and under their guidance we completed the excavation of the niche and the repairs to the cutterhead itself on May 15, 2013.”

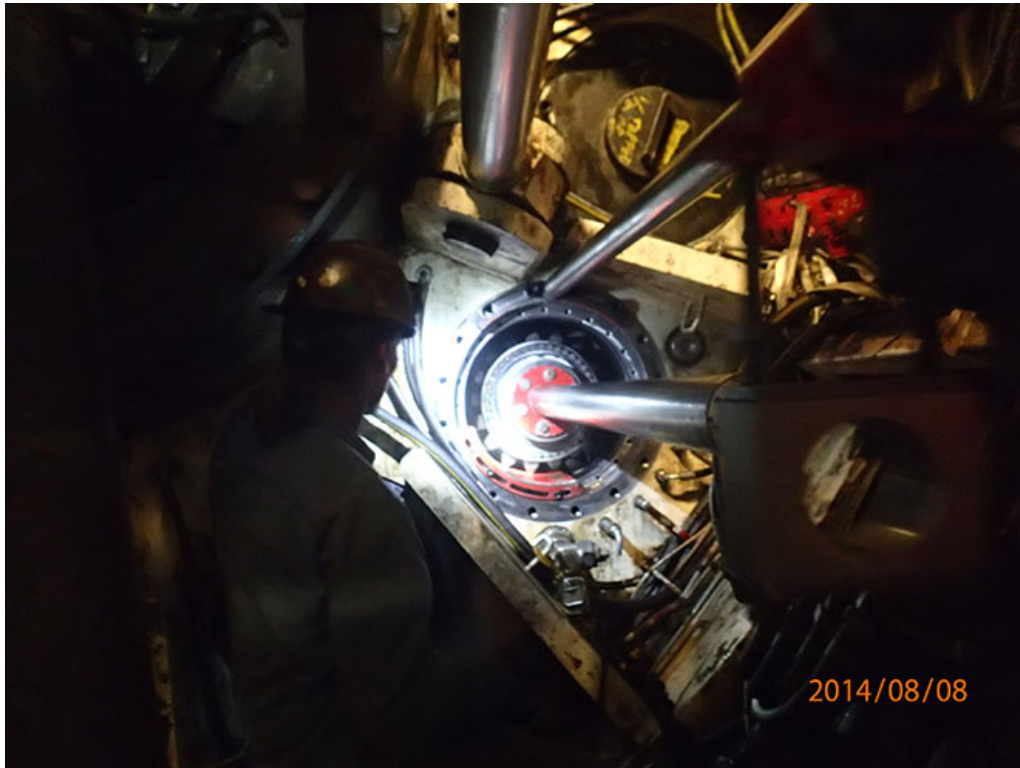
*Performing repairs on the drive motor pinions*

After restarting the drive in February this year (2014), and following a number of further mode switches, another problem soon presented itself. “During a run in closed mode we started seeing metal showing up in our lubrication system at which point we had to stop to pull off all our gear boxes, motors, pinion gear housings, and then remove the pinion gears where we found the problem was with the pinion gear bearings, which all had to be replaced,” said Nickerson.
